**BOLIDEN
KYLILAHTI**

**BIODIVERSITY
GRI REPORT
2021**

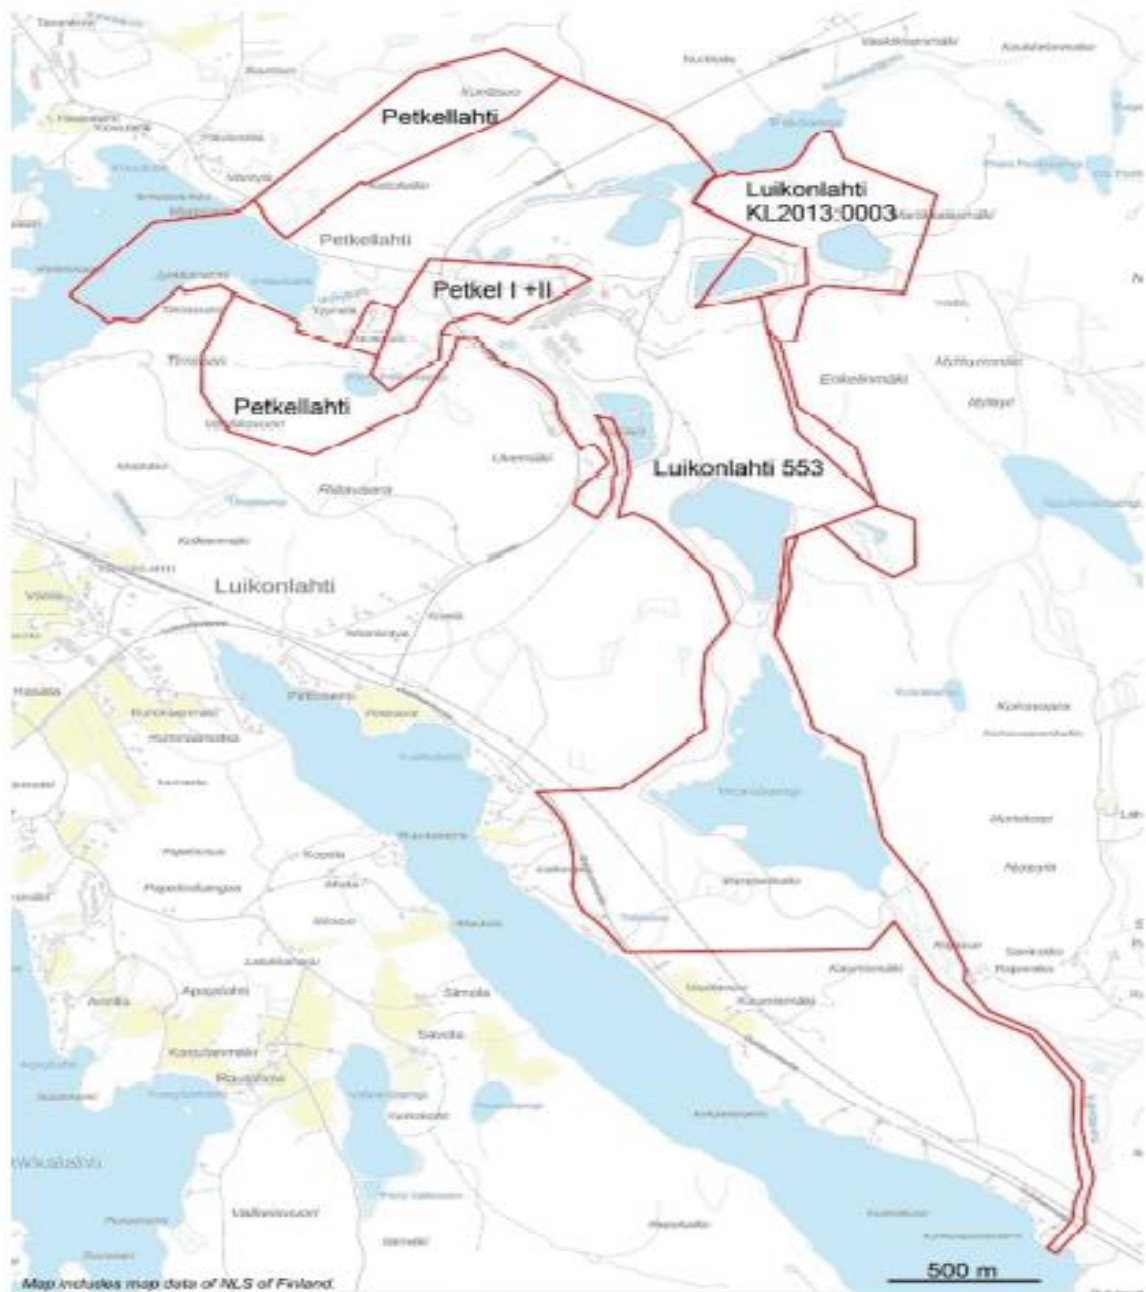
Figure 3. Illustration of Luikonlahti mining licenses.

The mining districts in force in the area are: Luikonlahti 1–2, 4 and 6–11, Petkel I and II and Petkellahti. During 2015, the auxiliary area of the Luikonlahti mining district was reduced to an area of 17.8 hectares. The discontinued part was located west of the railway line west of Heinälamme and the closure was applied for at the request of the owner of the property in the area. Since then, the areas of operation of the Luikonlahti mining district, other auxiliary areas and mining permit areas under the new Mining Act have remained unchanged.
